NOTICE TO AGENTS, BERTH AND SHIP OPERATORS No. 4 of 2020

PILOT TRANSFER ARRANGEMENTS

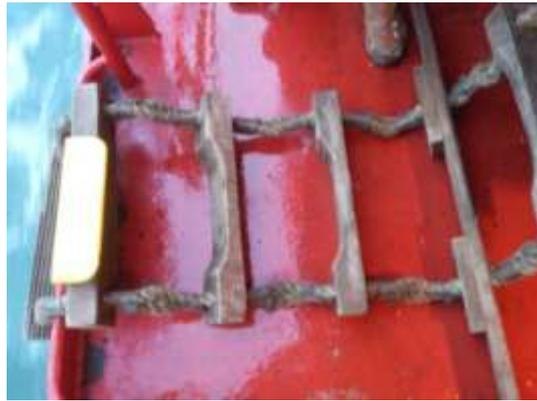
Pilot ladder secured by deck tongue

Although a common securing arrangement which may appear a simple solution to install and adjust a pilot ladder, this method is deemed **non compliant** in the UK and dangerous for anyone who might have to use it. Applicable regulations:

ISO799-1(2019) states that: *"each side rope shall have a breaking strength of at least 24kN and the diameter should be 18mm."*

ISO799-1(2019) states that *"each step shall have a strength of at least 8,8 kN"*

IMO1045(27) 2.1.1 *"the securing points etc shall be at least as strong as the side ropes"*.

Therefore, each side rope can handle 2400 kilos (4800 together) and that each step can handle a weight of 880 kilos. The strength of the deck tongue is often unknown nor tested and certificated.

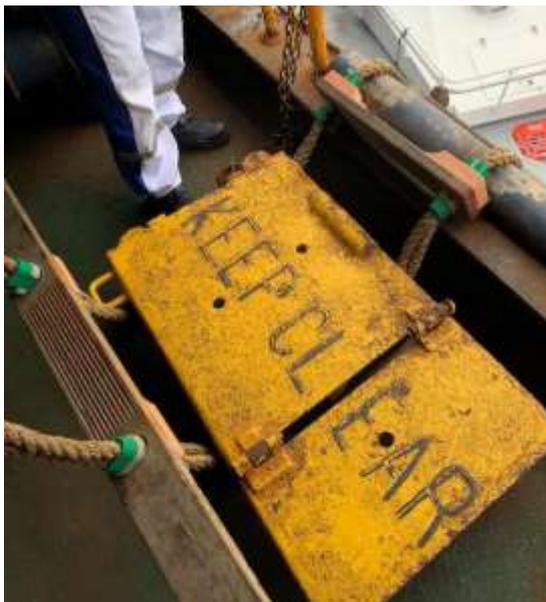
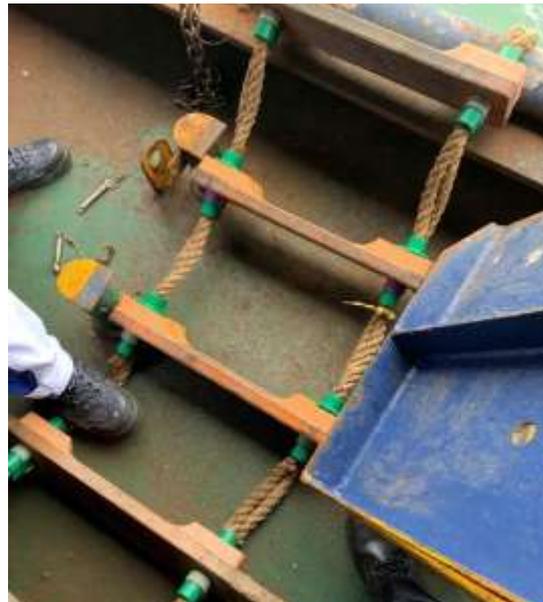
Platform placed over the securing area of the ladder

A compliant platform built over the securing area of the pilot ladder can be seen to improve access, but can hide a non-compliant securing arrangement.

Pilots who encounter a platform over the ladder will often ask to check the securing arrangement. Should this be found non-compliant it may be reported as a deficiency to the Port Authority & local MCA office.

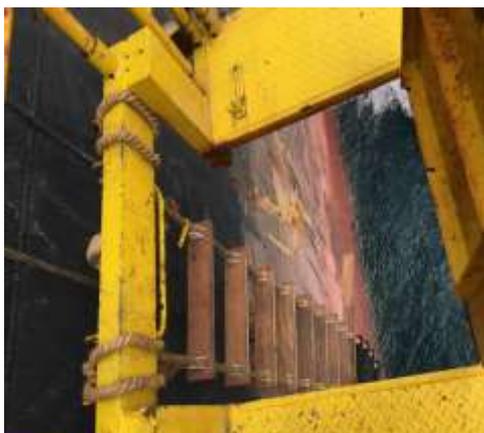
Pic 1

Where the vessels freeboard exceeds 9m an arrangement consisting of both accommodation and pilot ladders is used. Some vessels are still presenting arrangements with the trapdoor which has not met IMO standards since 2012. (Pic 1)

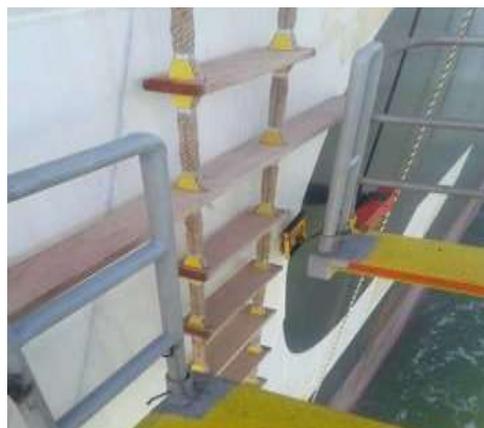
Pic 2

IMO A.1045(27) 3.7 states the ladder has to “*extend above the lower platform to the height of the handrails*” and remain in alignment with and against the ship’s side. (Pic 2)

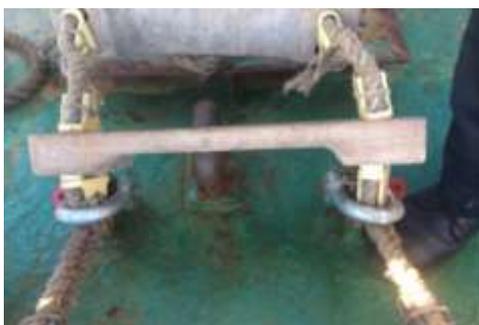
Securing Pilot ladder with Shackles

Shackles are a common pilot ladder securing deficiency. This is because although the IMO allows it: **IMO A.1045(27)**: 2.1.1 “*the securing strong points, **shackles**, and securing ropes should be at least as strong as the side ropes*” it must be noted the UK Authorities have declared the use of shackles as non-compliant, because this puts weight on the steps rather than the side ropes. When the pilot puts weight on the ladder, the ladder will move freely under the shackles until the next chocks and step has reached the shackles.
